# Richmond Refinery LPS Bulletin – Reliability

## TK-1400 Thrust Probe Failures (RLOP SD)

Richmond Refinery – RLOP  
TK-1400 H2 Recycle  
Compressor Turbine

Investigation #22505

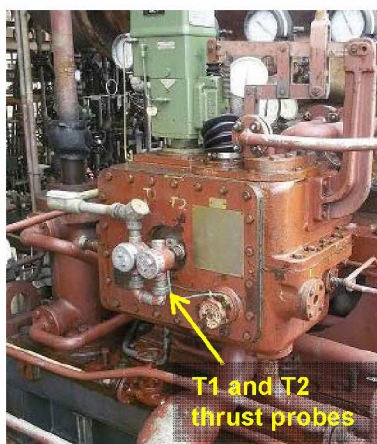
Photo of Thrust End  
of TK-1400

- 1) The conduit routing used for the thrust probe cables had an excessive number of 90° elbows without intermediate pull boxes. This caused the cables and connectors to be damaged when they were pulled into the conduit during installation.

- 2) There was initial undetected damage during installation, which over time caused drifting indications from the axial probe as compared to the true position leading to the eventual turbine trip.

- 3) The abnormal readings from thrust probes had been detected weeks before the shutdown. Wiring was checked 36 hours prior to the trip and adjusted so that the signal appeared to return to normal but without correcting the conduit routing issues the repair was unsuccessful. The readings began to drift very soon after completion.

- 1) Modify the TK-1400 thrust channel conduit between turbine and driver enclosure so as to allow cable installation without damage to cables.
- 2) Reinforce the use of the existing procedure for installing vibration probes on rotating equipment ([RR-517-P-7202](#)). This procedure includes direction to avoid a similar failure in future installations.
